Principal Investigator David Eng
Region Director Rod Seeley
Date of Report 10/01/2013
Subject Failure Investigation Report – Denbury Green

Failure Investigation Report – Denbury Gulf Coast Pipelines, LLC

CO2 Failures - December 20, 2010 & February 14, 2011

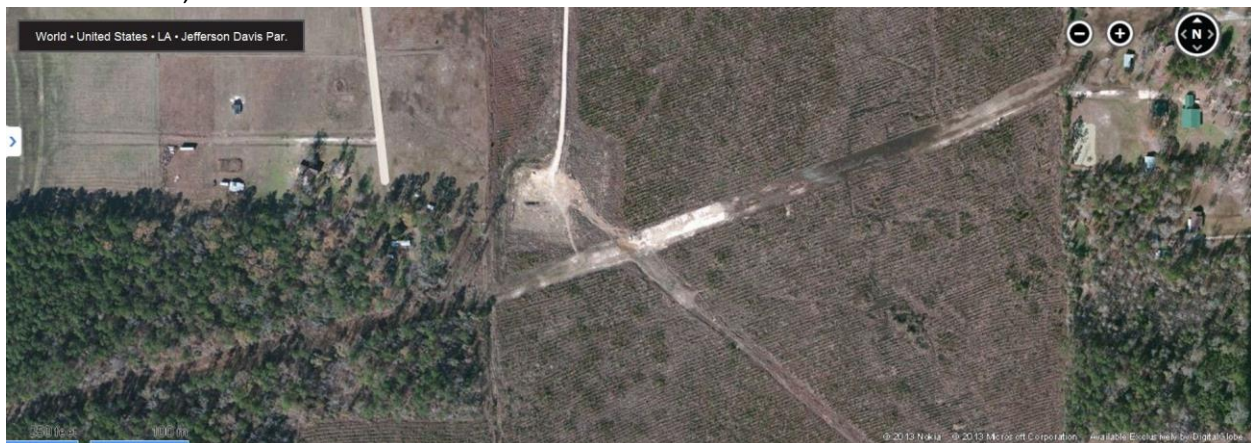
2010 Release in approximate center of photo

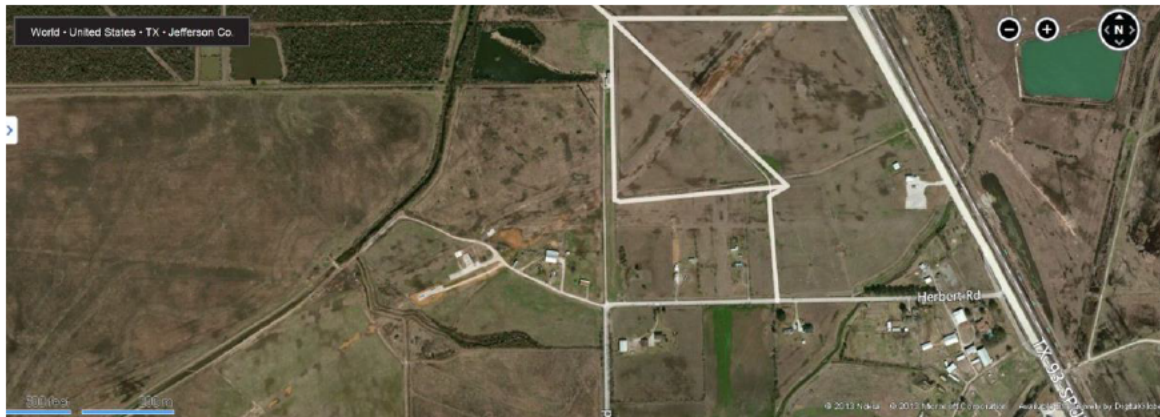
2011 Release in approximate center of photo

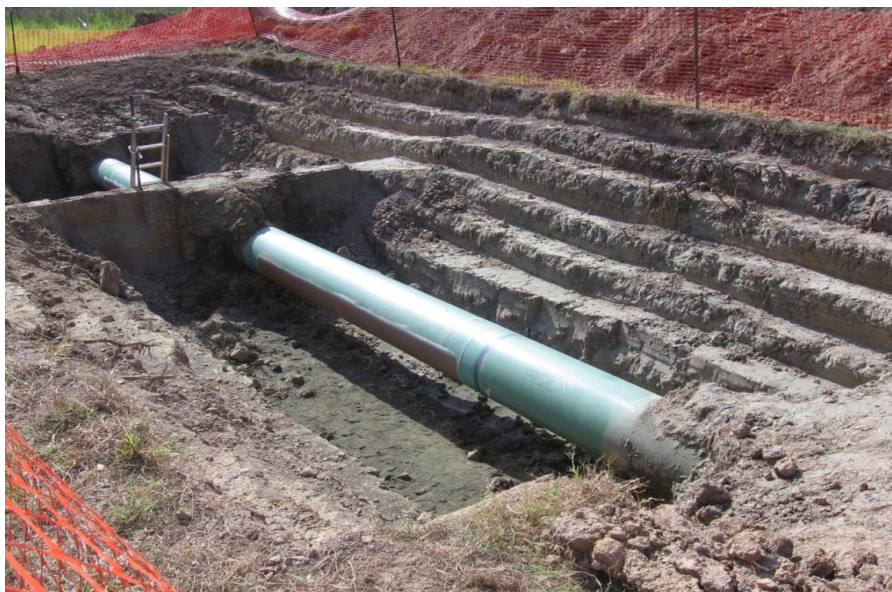
Those 31 joints were identified as the most likely to contain a penetrator flaw. Denbury furthermore proposed to sample 10 percent of those joints (3 joints), perform investigative digs, expose the joints, and perform magnetic particle inspection and UT examinations on their longitudinal seams. PHMSA concurred with this decision. The three joints/sites were chosen for their similarities to the location of the previous failures. Prior to the digs, external corrosion direct assessment examination was performed at each site, which consisted of close interval surveys (CIS) and alternating current voltage gradient (ACVG) surveys, to investigate these areas by direct assessment and compare survey results against any external corrosion anomalies that were found. Confirmation digs were performed with the PHMSA investigator present.

Confirmation Dig of Identified Pipe Joint

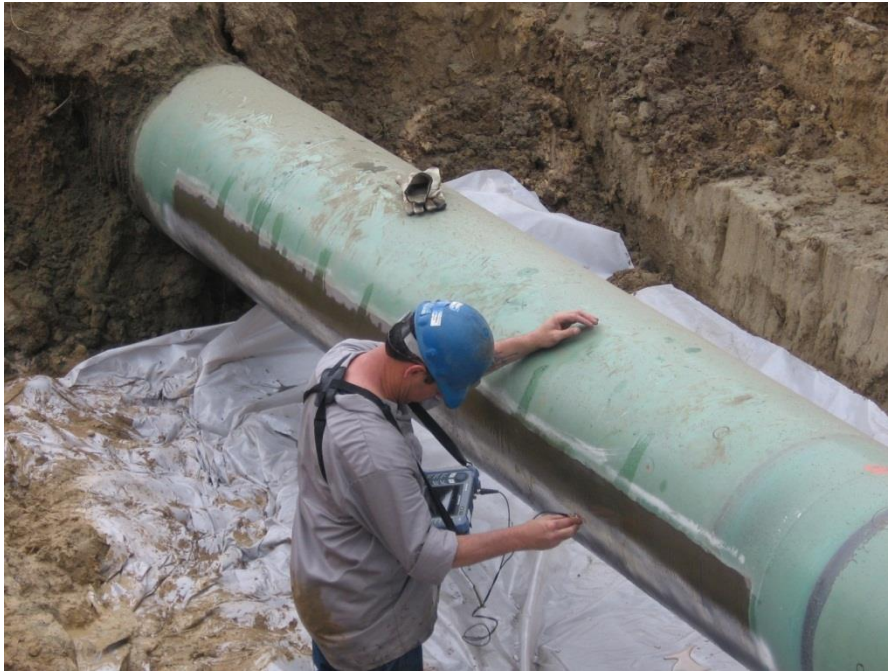
Field Ultrasonic Testing of Identified Pipe Joint's Long Seam for Potential Weld Imperfections "Penetrators"

- A magnetic particle inspection of the long seams found surface indications that were removed by light grinding. A re-examination by magnetic particle returned satisfactory results.
- An ultrasonic examination resulted in "No indications noted."
