USE OF SUBSTANDARD STEEL BY THE U.S. PIPELINE INDUSTRY 2007 TO 2009

**Plains Justice
June 28, 2010**

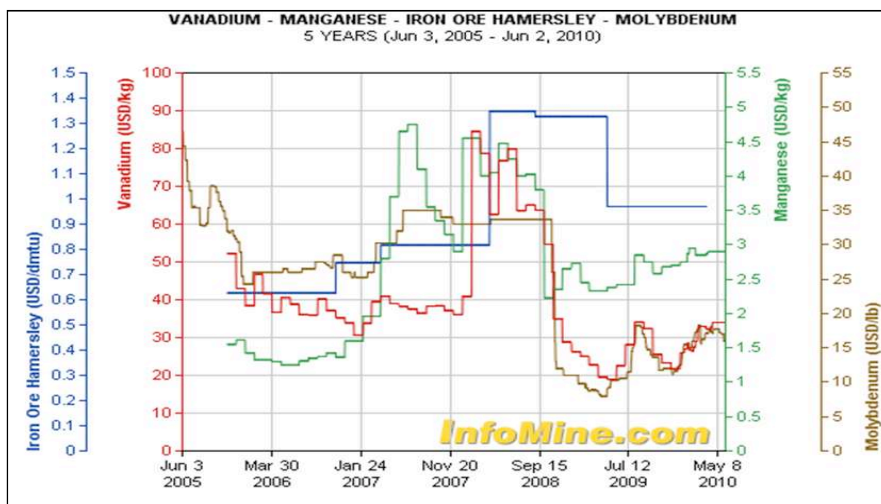
During the period when the defective pipe was fabricated, commodity prices soared, including prices for most metals. The following chart shows that the price for manganese more than tripled in 2007 and the price for iron ore and vanadium more than doubled in 2008.

This market evidence indicates that steel mills faced substantially higher prices for raw materials than they likely anticipated. It is reasonable to question whether these dramatic changes in commodity prices shifted steel mill priorities toward meeting production and price goals and away from quality control, including control over the quality of raw materials and steel formulation. However, in the absence of systematic metallurgical analysis, it is not possible to know with certainty that a pattern of production of mis-alloyed steel existed, and that this was the root cause of the production of substandard pipe by manufacturers.

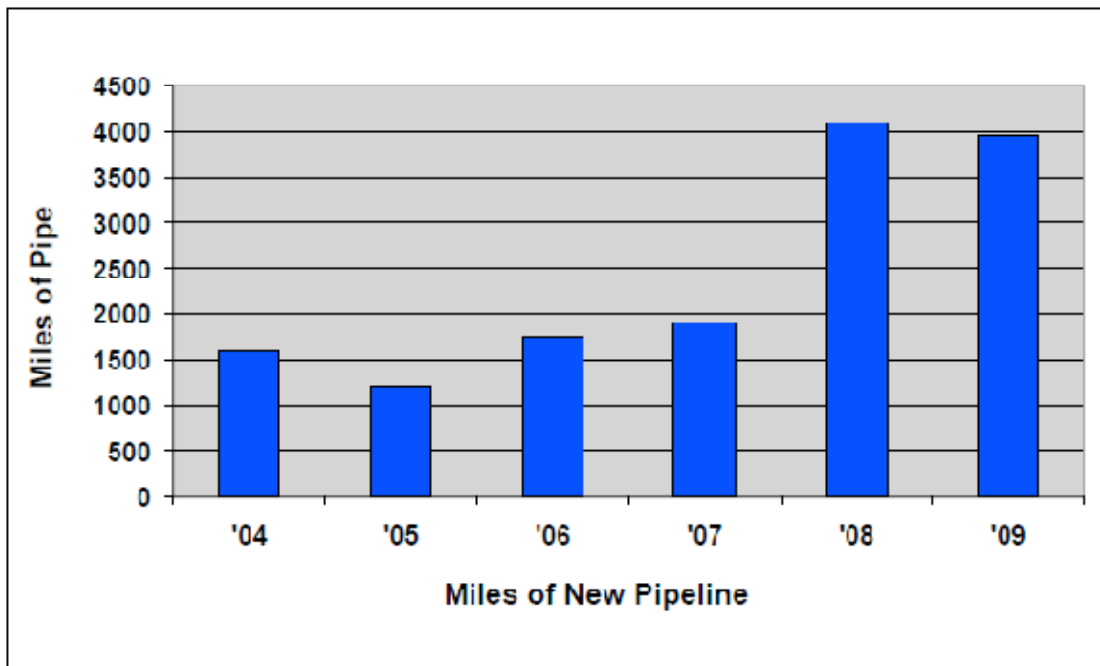
Source: ICF International

During this same time period, demand for steel increased dramatically. According to the industry graph below, between 2007 and 2008 the miles of new pipe installed by the industry doubled.⁵⁴

This increase in installed miles of pipe is reflected in a corresponding growth in sales of pipe by pipe mills. For example, from 2006 to 2009, Welspun increased its pipe production rapidly, registering nearly 50% increases in sales in fiscal years 2007 and 2008.⁵⁵ Its pipe volume production rate increased by 34% in the third quarter of 2008 alone.⁵⁶ This rapid growth likely required the retention and training of new employees, pressed steel and pipe mill infrastructure to its limits, and resulted in substantial management pressure on personnel to meet production deadlines. Such production conditions could have adversely impacted quality control.
